LABORATORY ANALYSIS REPORT

Laboratory Number – 601178 - ID: 26-203 BEARING FAILURE ANALYSIS

Laboratory Number – 601179 - ID: 203-7000 HOURS, BEARING FAILURE ANALYSIS

Laboratory Number – 601180 - ID: 204-7000 HOURS, BEARING FAILURE ANALYSIS

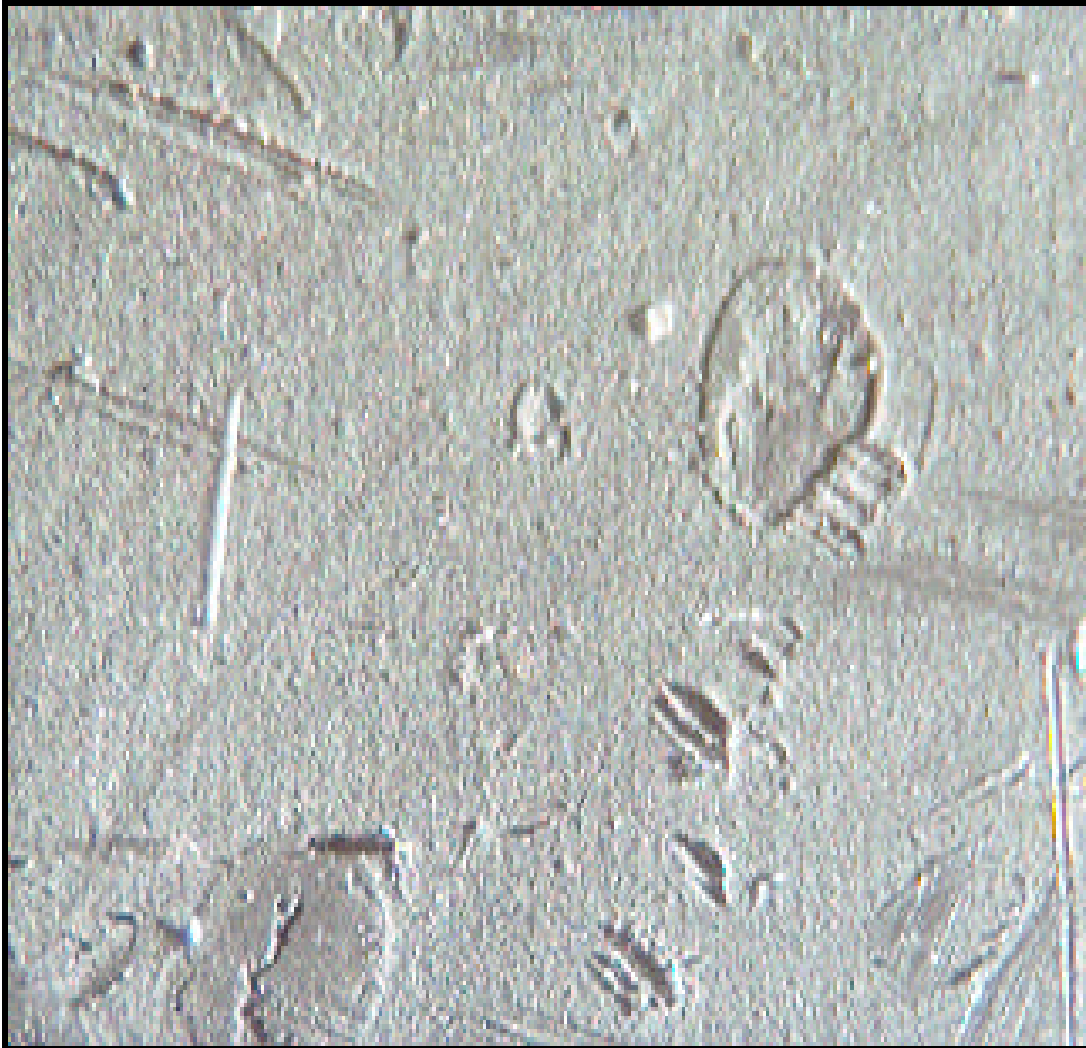
Optical Micrograph of Bearing Surface as Received

Discussion: The micrograph shows the bearing surface has sustained damage. The raised areas are thought to be caused by the “Oil Balls” embedded in the bearing and deforming elevating the softer overlay. The numerous scratches and gouges are thought to be from abrasive materials (dirt) and possibly handling prior to our receiving the bearing. The following SEM images along with the EDS analysis of the elements support these conclusions.

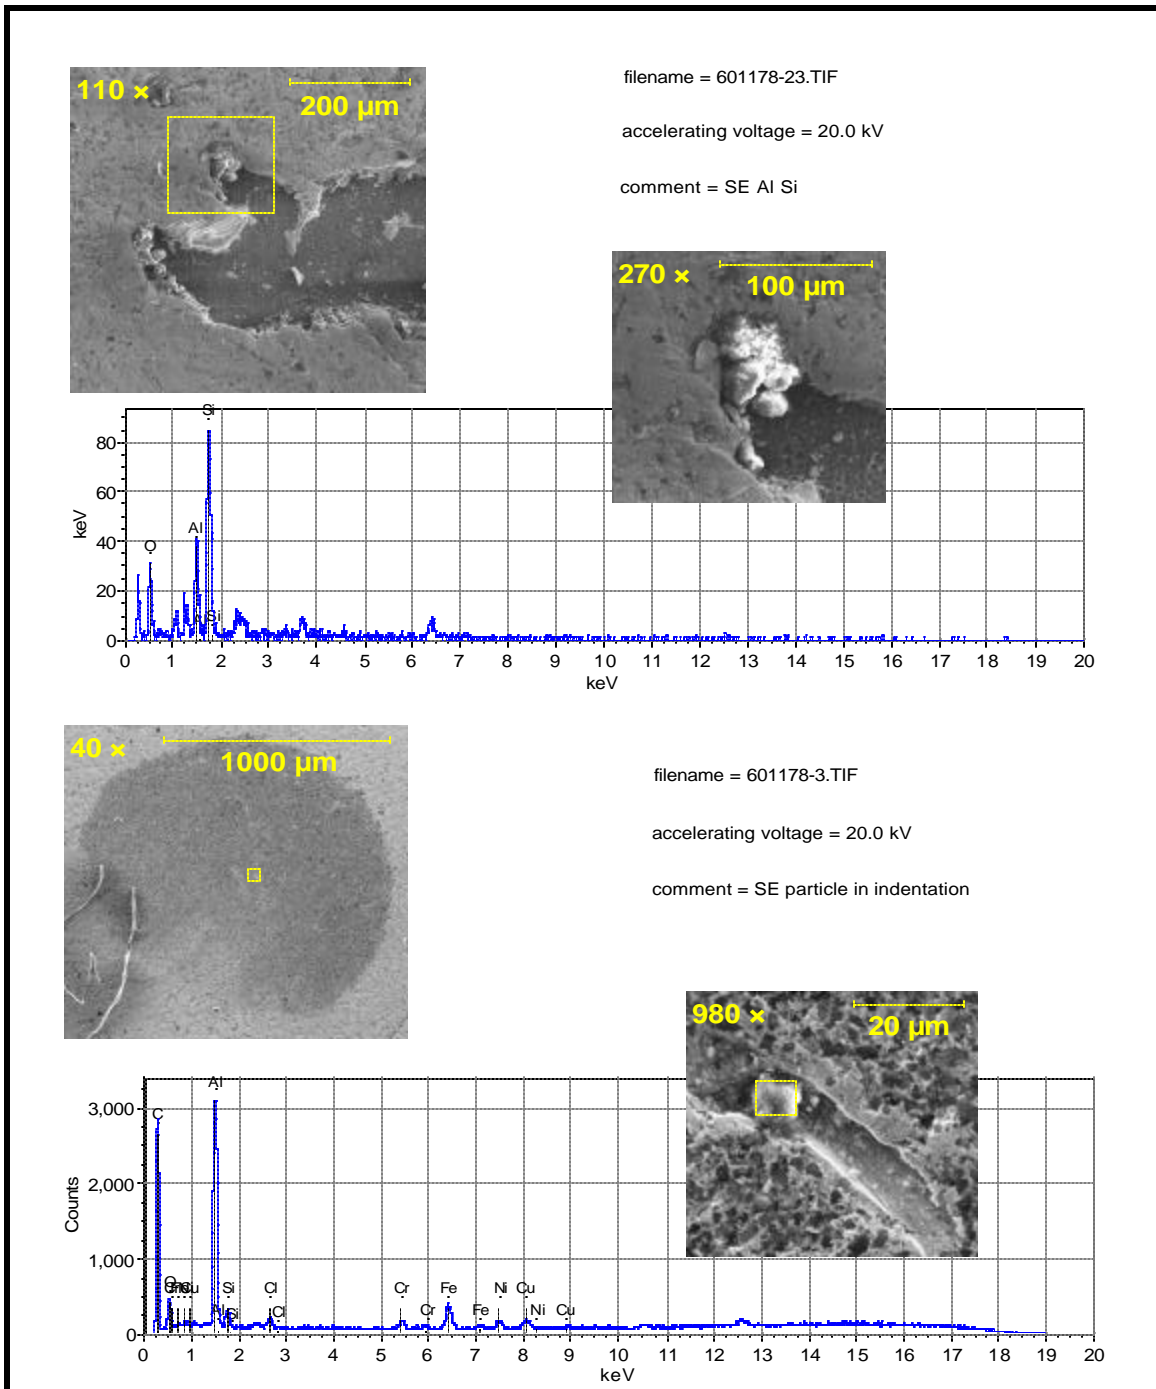
TOP images show area of missing overlay and silicon and aluminum debris. Probable source is the environment. We speculate that embedment of foreign particles destroys the physical integrity of the overlay, allowing it to be removed or eroded by friction and fluid forces in the oil film. It is removed only in the thin oil film section.

BOTTOM images show raised portion of overlay with honey comb surface which include embedded “oil balls” and large gouge due to aluminum particle.

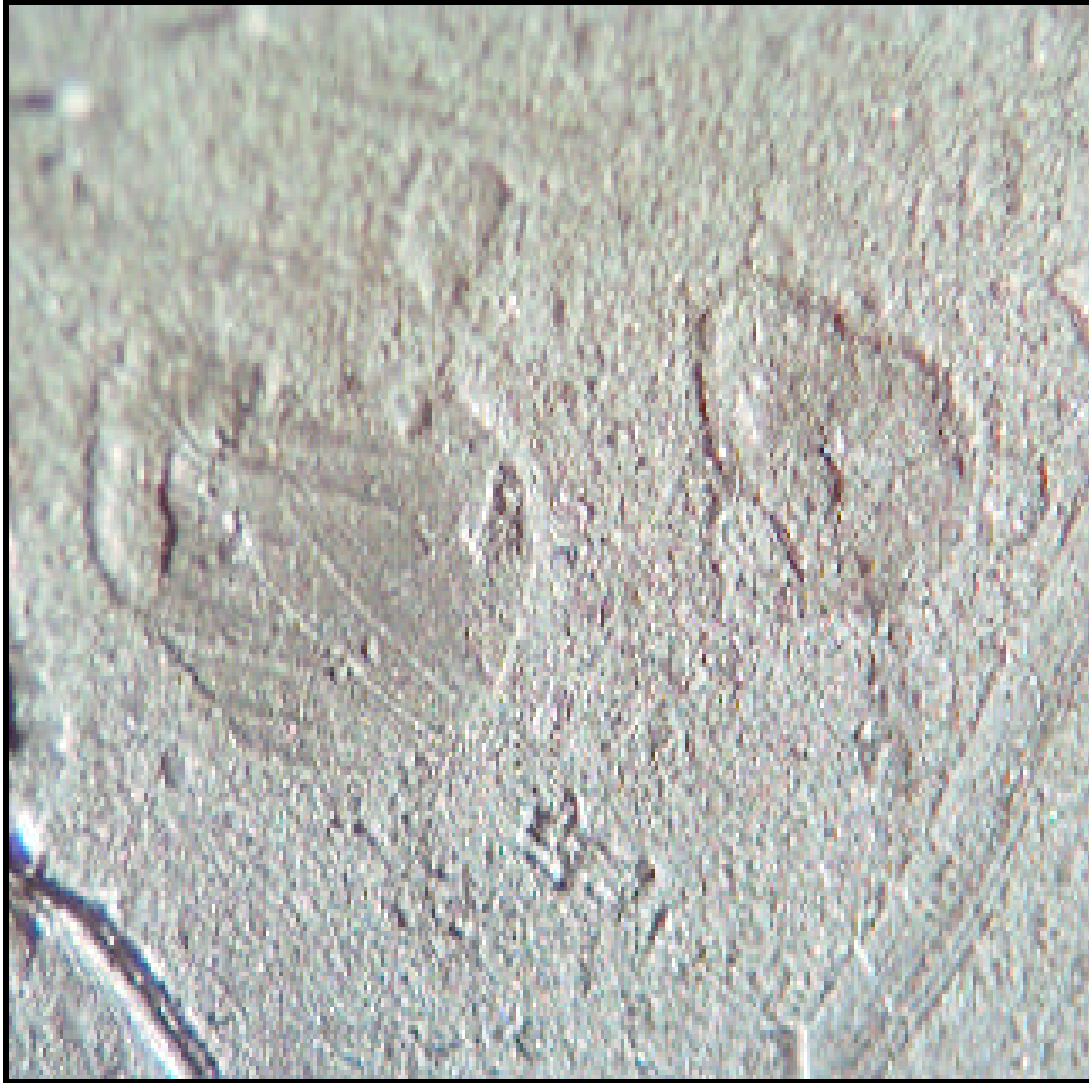
Optical Micrograph of Bearing Surface as Received

Discussion: The micrograph shows the bearing surface has sustained damage. The raised areas are thought to be caused by the “Oil Balls” embedded in the bearing and deforming and elevating the softer overlay. The numerous scratches and gouges are thought to be from abrasive materials (dirt) and possibly handling prior to our receiving the bearing. The following SEM images along with the EDS analysis of the elements support these conclusions.

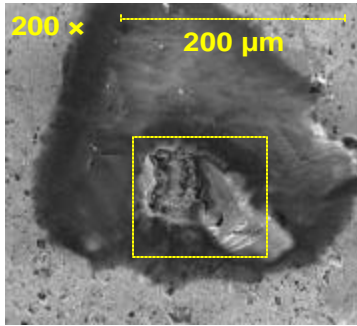
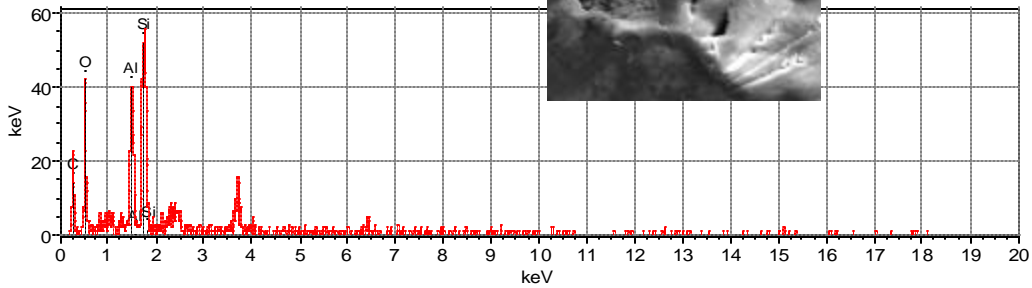
filename = 601179-1.TIF

TOP images show embedded particle of silicon and aluminum in overlay. Probable source is the environment. BOTTOM images show distressed and missing overlay with numerous silicon and aluminum particles surrounding the damage.
ID: 203-7000 HOURS, BEARING FAILURE ANALYSIS

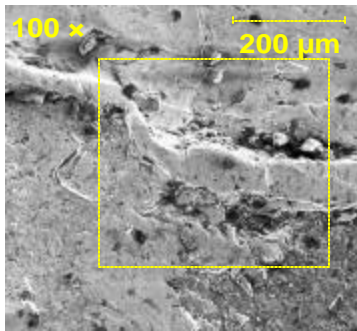
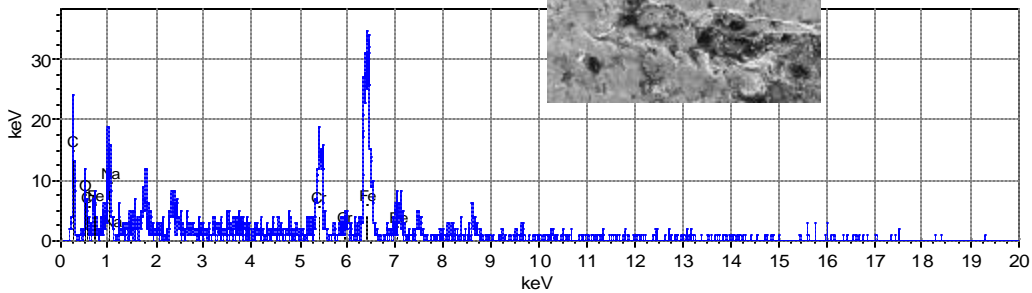
filename = 601179-3.TIF

TOP images show distressed overlay with iron and chromium wear debris around the damaged area. BOTTOM images show raised portion of overlay with honey comb surface which includes embedded “oil balls” rich in calcium and phosphorus.
ID: 203-7000 HOURS, BEARING FAILURE ANALYSIS

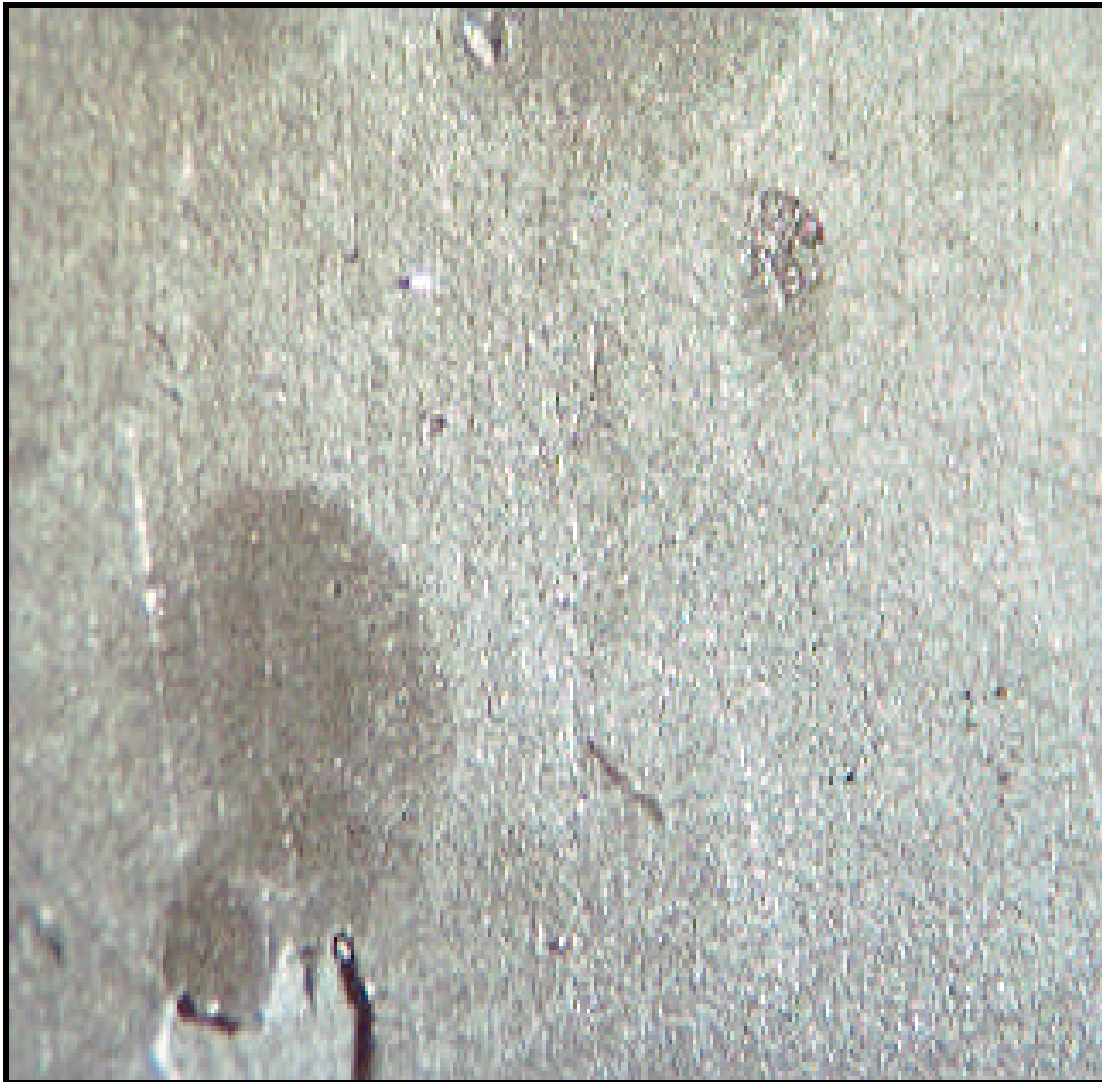
Optical Micrograph of Bearing Surface as Received

Discussion: The micrograph shows the bearing surface has sustained damage. The raised areas are thought to be caused by the “Oil Balls” embedded in the bearing and deforming elevating the softer overlay. The numerous scratches and gouges are thought to be from abrasive materials (dirt) and possibly handling prior to our receiving the bearing. The following SEM images along with the EDS analysis of the elements support these conclusions.

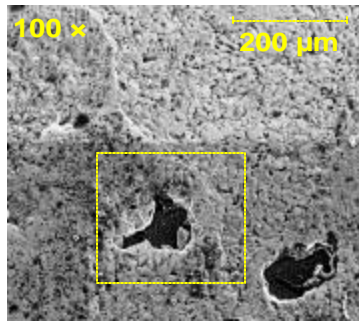
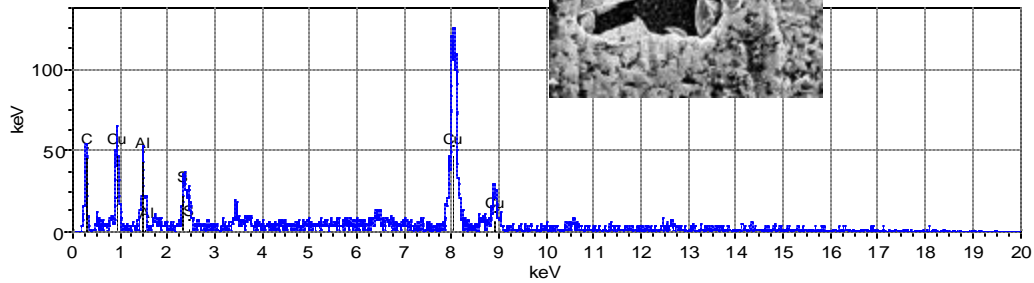
filename = 601180-5.TIF

TOP images show area of missing overlay and a large copper wear debris particle in the void.

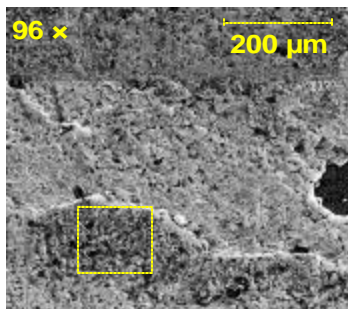
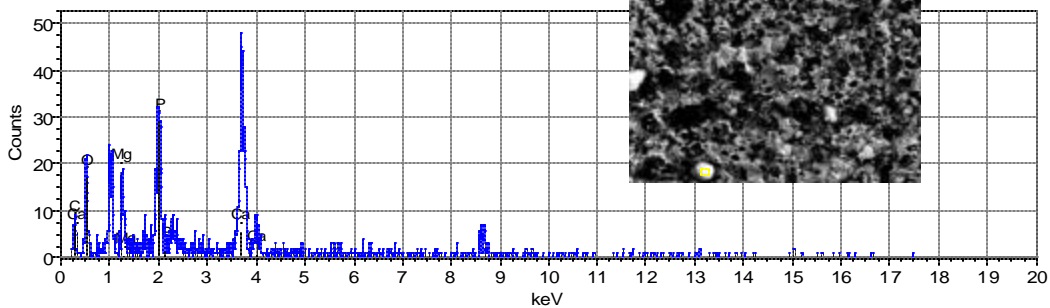
filename = 601180-7.TIF

BOTTOM images show raised portion of overlay with honey comb surface which includes embedded “oil balls” rich in calcium and phosphorus.
